**Local Perceptions of Climate Change:
A reference to changes in water level**

by
Uthpal Kumar and M. Rashed Jalal

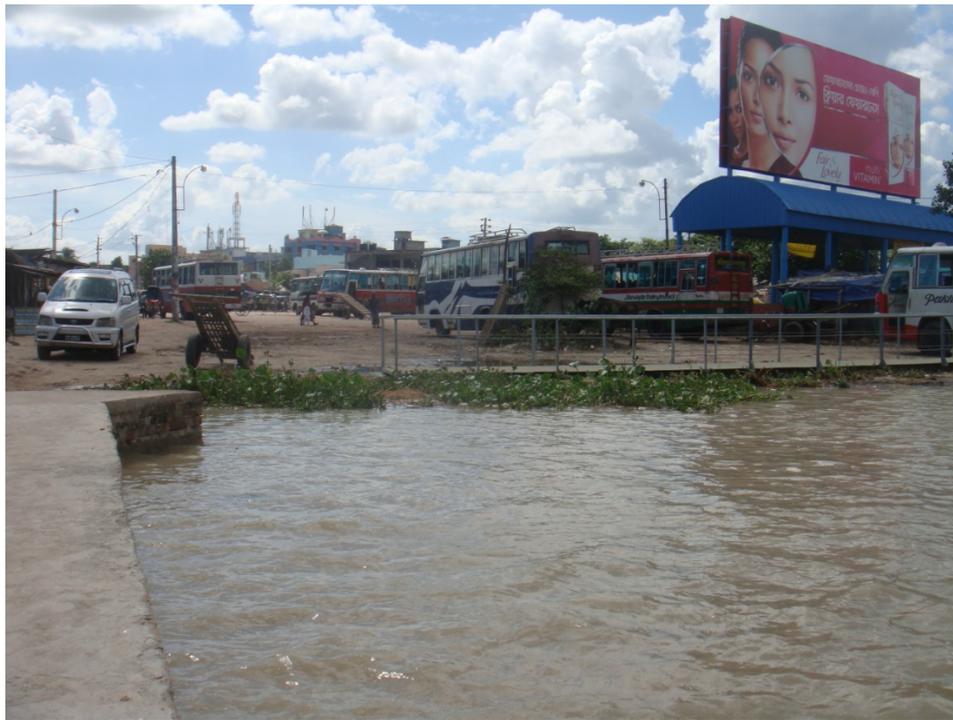
Figure 2: The tidal water level reached to the road level of Rupsha ferry ghat.

A local boat operator Md. Rubel Sikder (23) said that during high tide Rupsha ferry ghat road becomes flooded. After construction of the Rupsha Bridge this river has been drying day by day. He added that width of the river Rupsha has been decreased at least 200 ft during the last five years. He said that he did not hear anything about climate change and its impact in Khulna. Mr. Nazrul Islam (60) is a local shopkeeper at Rupsha ferry ghat area since 1978. At present his

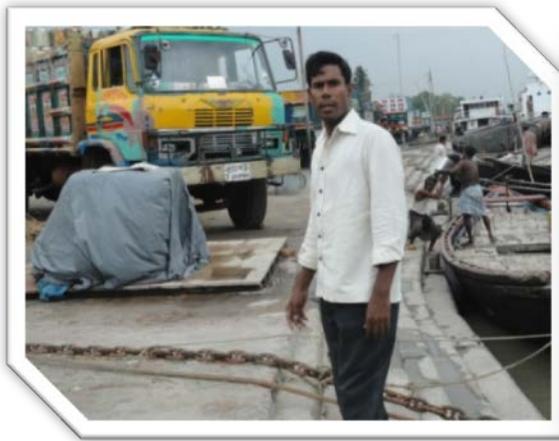
Figure 3: BIWTA's port and traffic officer Mr. Munshi Mohiuddin is showing the signature changes in water level Rupsha-Bhairab river system at Railway *Kastom Ghat* in Khulna.

According to Port and Traffic Officer of Bangladesh Inland Water Transport Authority (BIWTA), Mr. Munshi Mohiuddin, water level of the Rupsha has been increasing. He said, the present yard of the BIWTA was built about 25 years back. That time yard was not flooded because it was built about 1-2 ft high above the high tide level. But now it becomes flooded during high tide in most of the year, especially during monsoon. This indicates that water level has been increased. In July water level becomes very high and that time main road at BIWTA ghat goes under water. Last year water level increased more than 1ft than that of the previous year.

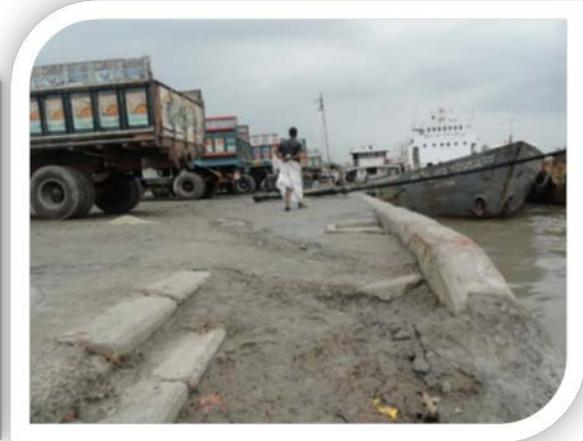
Figure 2: Figure shows the tide protection embankment at Railway *Kastom Ghat* area. Earlier it was about 1-2 ft. high from the high tide level but now it becomes flooded due to tidal influence. The sediment signature shows the flooding condition of the embankment BIWTA *Kastom Ghat*.
