**Local Perceptions of Climate Change:  
A reference to changes in water level**

by  
*Uthpal Kumar and M. Rashed Jalal*

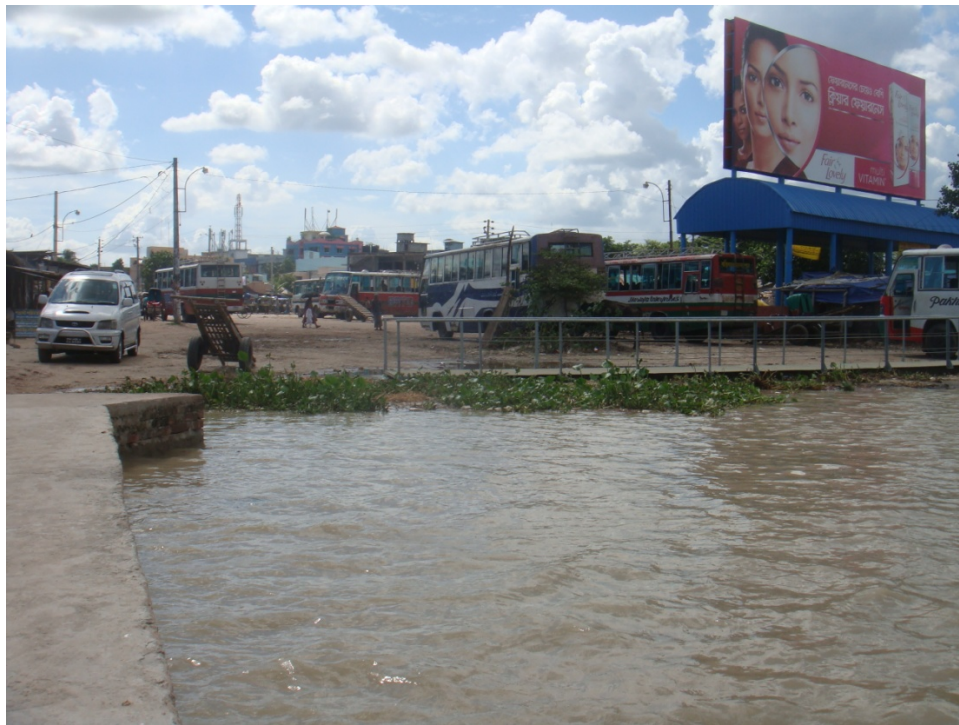
**Figure 2:** The tidal water level reached to the road level of Rupsha ferry ghat.

A local boat operator Md. Rubel Sikder (23) said that during high tide Rupsha ferry ghat road becomes flooded. After construction of the Rupsha Bridge this river has been drying day by day. He added that width of the river Rupsha has been decreased at least 200 ft during the last five years. He said that he did not hear anything about climate change and its impact in Khulna. Mr. Nazrul Islam (60) is a local shopkeeper at Rupsha ferry ghat area since 1978. At present his

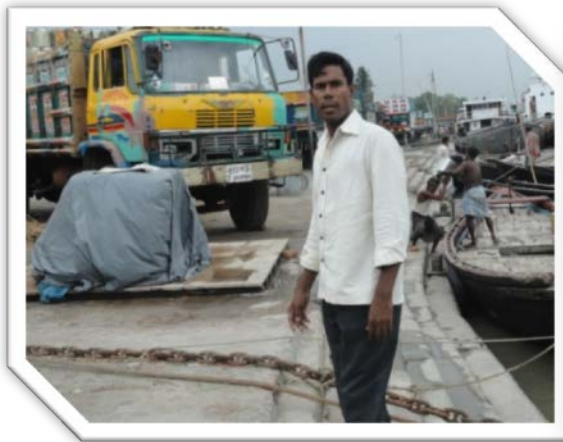
**Figure 3:** BIWTA's port and traffic officer Mr. Munshi Mohiuddin is showing the signature changes in water level Rupsha-Bhairab river system at Railway *Kastom Ghat* in Khulna.

According to Port and Traffic Officer of Bangladesh Inland Water Transport Authority (BIWTA), Mr. Munshi Mohiuddin, water level of the Rupsha has been increasing. He said, the present yard of the BIWTA was built about 25 years back. That time yard was not flooded because it was built about 1-2 ft high above the high tide level. But now it becomes flooded during high tide in most of the year, especially during monsoon. This indicates that water level has been increased. In July water level becomes very high and that time main road at BIWTA ghat goes under water. Last year water level increased more than 1ft than that of the previous year.

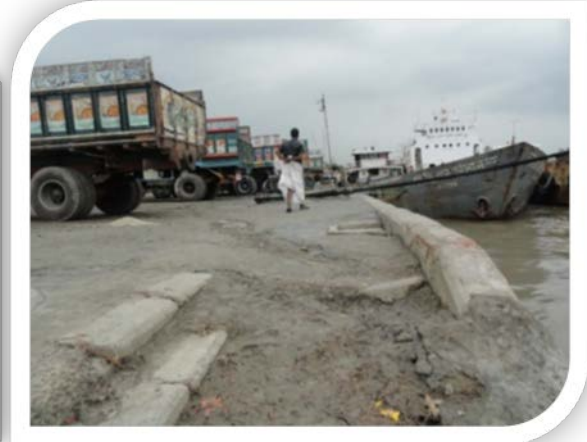
**Figure 2:** Figure shows the tide protection embankment at Railway *Kastom Ghat* area. Earlier it was about 1-2 ft. high from the high tide level but now it becomes flooded due to tidal influence. The sediment signature shows the flooding condition of the embankment BIWTA *Kastom Ghat*.
